Wildlife Vehicle Collisions (WVC) Sub-group: *The Sierra National Forest Highway 41 Culvert Project*

Carrie J. O'Brien (SNAMP), Anaë B. Otto (Sierra NF), Rick A. Sweitzer (SNAMP)

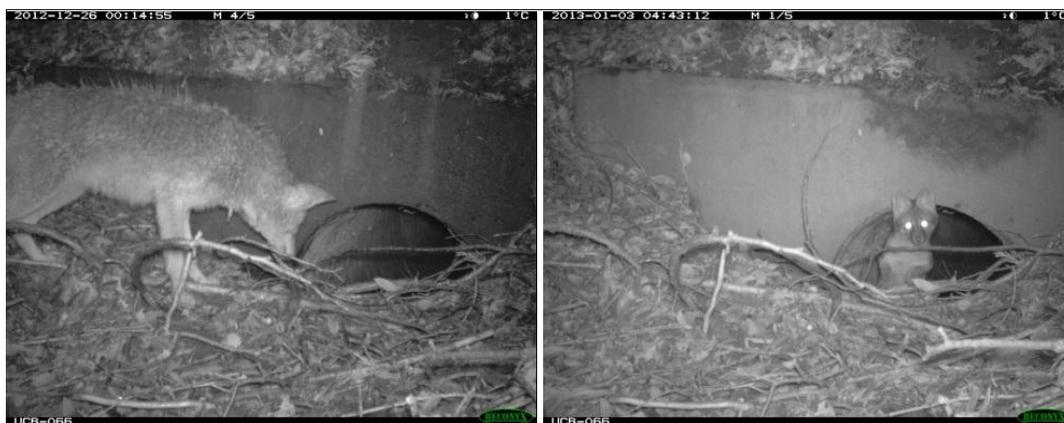
Figure 2. A coyote (left) investigates and then repels away from a culvert on Highway 41, and a gray fox (right) using the same culvert to cross under the road.

Results: Our camera surveys unambiguously identified that fishers and other wildlife are actively utilizing several of the existing culverts on Highway 41 as crossing structures (Table 1, Figures 2-4). We determined that fishers used culverts to cross under Highway 41 at two separate locations (Happy Camp and Westfall), and they also used two larger culverts to pass beneath a forest road (road 5s17) immediately adjacent to Highway 41. Multiple other species of wildlife were identified as using culverts including black bear (*Ursus americanus*), raccoon (*Procyon lotor*), gray fox (*Urocyon cinereoargenteus*), and ringtail (*Bassariscus astutus*) (Table 1).

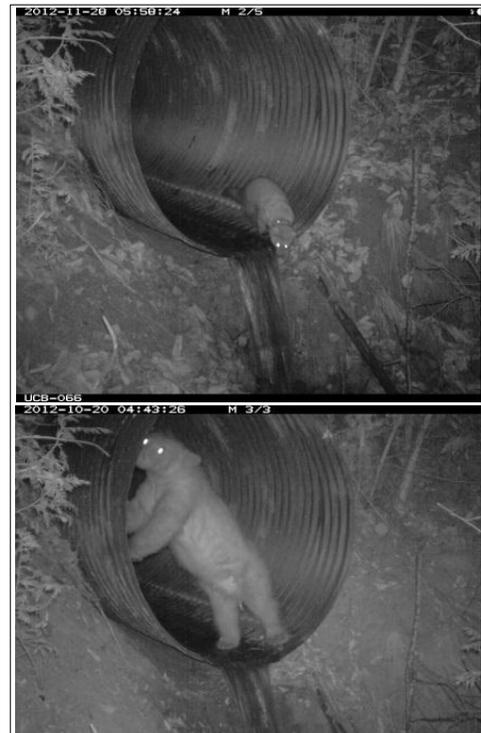
Figure 3. Camera images detecting a radio collared fisher (top) and a black bear (bottom) using the same large culvert to cross under forest road 5s17.

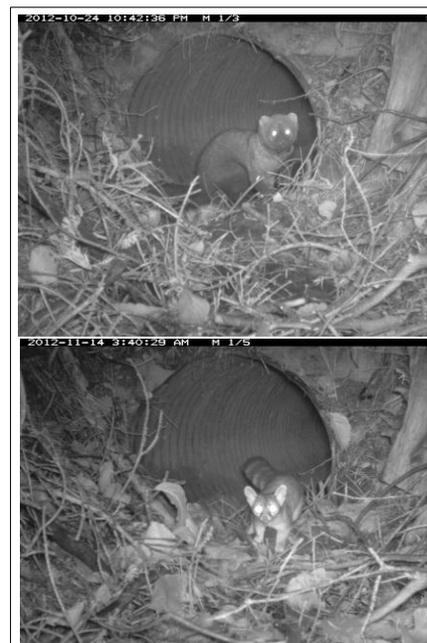
Figure 4. Camera images of a radio collared fisher (top) and a ringtail (bottom) using the same culvert to cross under Highway 41.
